**2023-2024**  
**Willington Public Schools: Board of Education**  
**Capital Improvement Project Preparation**

**Center School Priorities**

### **Hall School Priorities:**

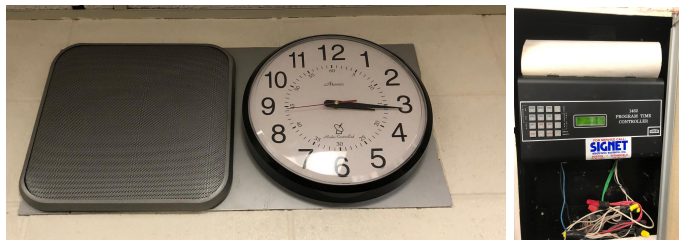
**1. CES - Clock System/PA/Security Strobe (submitted December 2019)**

The clock and public announcement system are outdated and we are unable to get parts. Many clocks have been replaced with generic battery-operated clocks and the times vary from room to room. The outdated system is hard coded to the old daylight savings time which took effect in 2007. The few remaining hard-wired clocks do eventually sync, but the battery clocks always show slightly different times. Many of the battery-powered clocks are designed to automatically set from the atomic signal but are unable to receive the signal inside the schools.

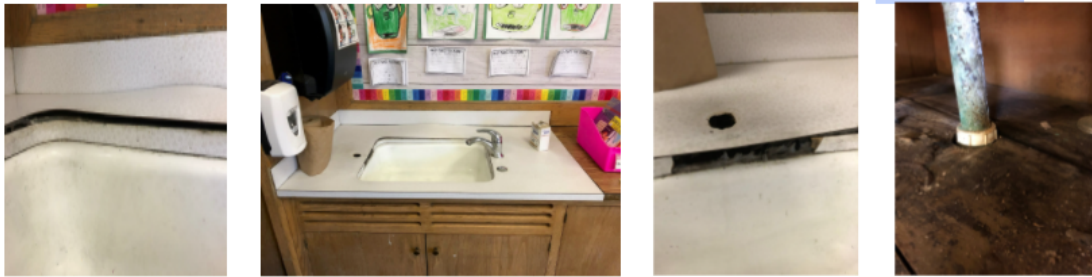
**2. CES - Plumbing Work: previously Classroom Sinks, Cabinets, and Plumbing (6)**  
**(submitted December 2020)**

Some of the classroom sinks, cabinets, and plumbing at the elementary school need to be replaced. The countertops are failing due to water damage and the plumbing is seized and does not have shut-off valves.

Some sink cabinets are original from 1952, while others have been replaced over the years and only require some minor repairs such as replacement faucets or drain pipes.

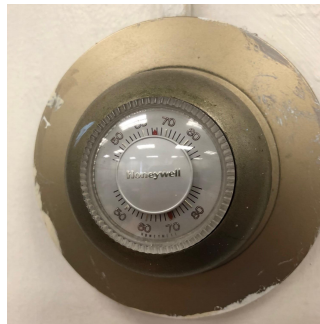
### **3. CES - Heating Project: Upper Wing (submitted December 2017)**

The steam project will upgrade valves and traps, as well as replace old mercury thermostats with Delta Thermostats. This will provide greater control over classroom temperature as well as energy savings with computer-enforced night setbacks. Once part of the Delta system, temperatures can be monitored remotely. This project does not include the replacement of steam pipes.

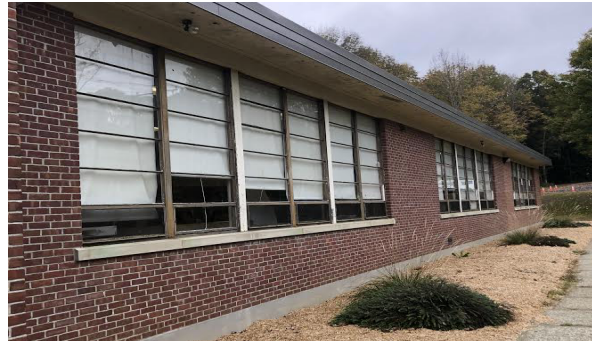
### **5. CES - Window Replacement: Upper Wing (submitted December 2016)**

The upper wing at Center School still has the original 1950s single pane glass. We would significantly increase our energy efficiency with the completion of this project, and also improve security.

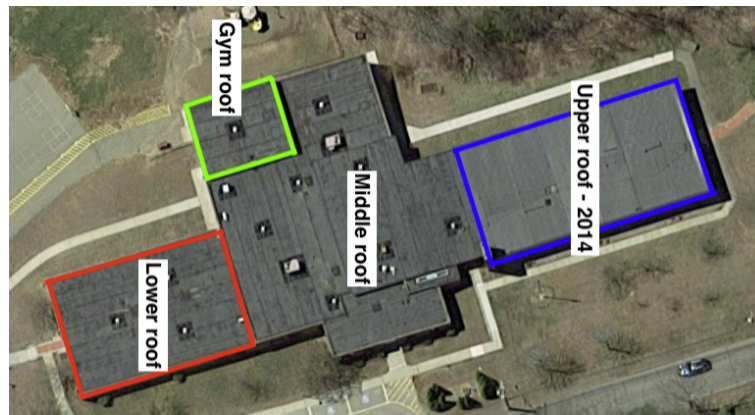
**6. CES - New Roof: Lower, Middle, and Gym Roof**

The upper wing roof by the gravel parking lot was replaced in 2014. All other sections of the Center School roof are in need of replacement. Numerous leaks occur throughout the lower wing despite patching. We will need to add \$8,000 in our budget for patching if the new roof is not included in CIP.

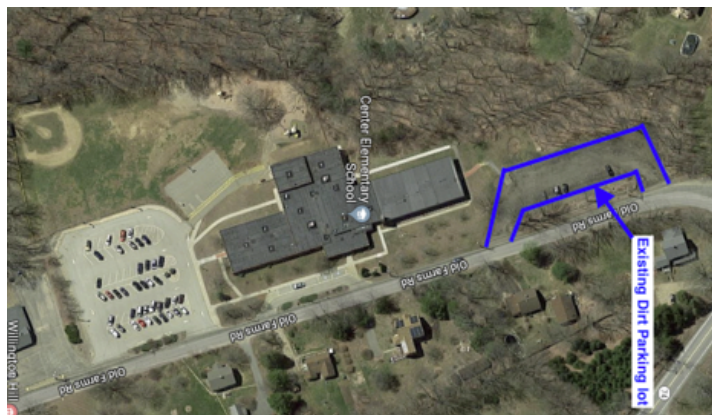
**8. CES - Pave Upper Parking Lot (submitted December 2018)**

The existing gravel parking lot is sloped towards the school and washes out when it rains. The town has installed a culvert to minimize damage. We are also unable to paint lines for parking spaces, and plowing is a challenge in the winter. The area is approximately 2,500 square feet (250x100).

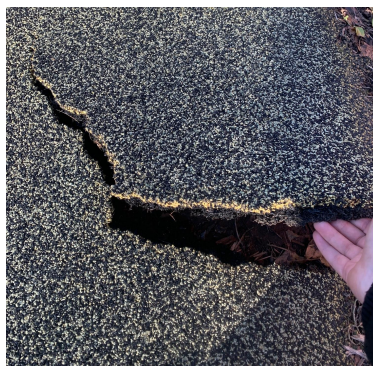
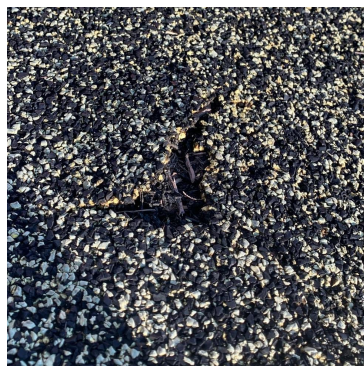
#### **9. CES - Playground: Poured Rubber Surface (submitted December 2018)**

A poured rubber playground would provide better handicap accessibility and ensure uniform fall protection which allows us to keep the playground open throughout the winter. The small section that is currently poured rubber is starting to fail as a result of improper site prep work. A large portion of the \$90,000 estimate is to ensure proper drainage under the rubber.

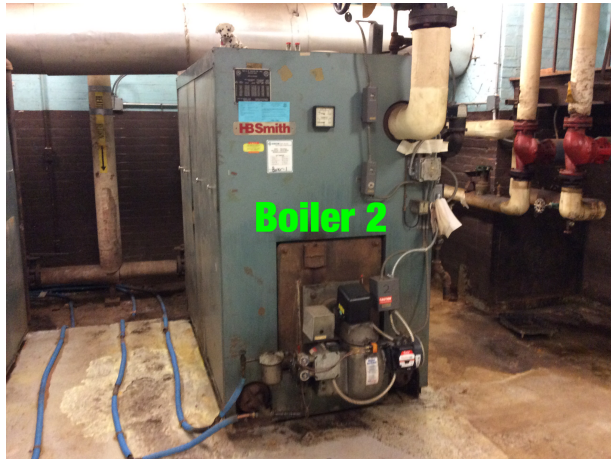
## **3. HMS - Boiler Replacement (submitted December 2017)**

The boiler at Hall School is at the end of life and is inefficient. The first boiler was replaced in 2020.

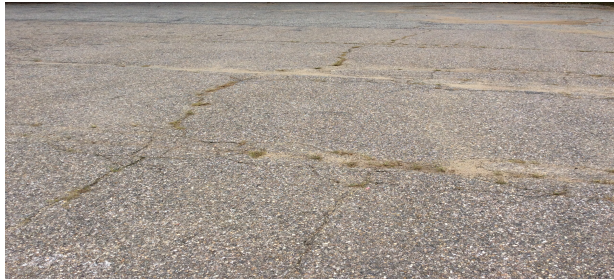
## **5. HMS - Pave Parking Lots (submitted December 2019; previously chipseal December 2016)**

The parking lot at HMS needs to be torn up and paved as two separate contractors have said the parking lot has an excessive number of cracks and sealing will only get you a few years of additional life.

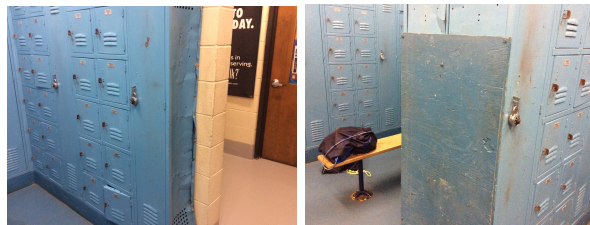
#### **6. HMS - Locker Replacement (submitted December 2016)**

The lockers in the boys locker room are in poor condition and need to be replaced. Repairs have been completed throughout the years.

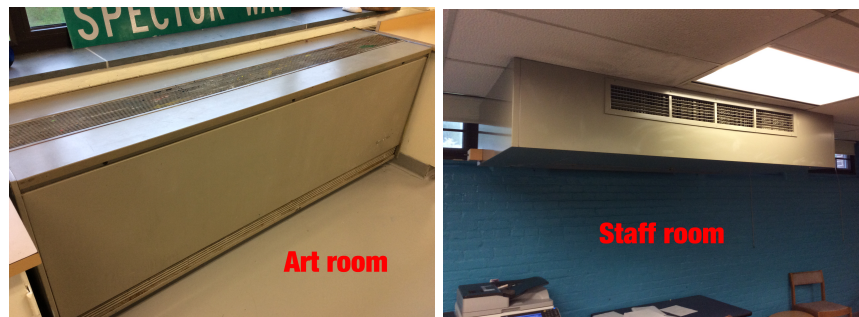
#### **7. HMS - Unit Ventilator Replacement (submitted December 2018)**

This project includes the replacement of 8 classroom unit ventilators. One unit was replaced in 2018 (insurance claim) and the existing units are difficult to get repair parts.

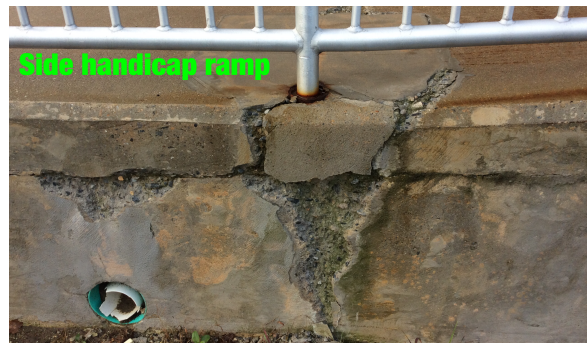
#### **8. HMS - Sidewalk/Landing Ramp Replacement (submitted December 2016)**

The ramp on the side of the building has been repaired, but continues to crumble and needs replacement.

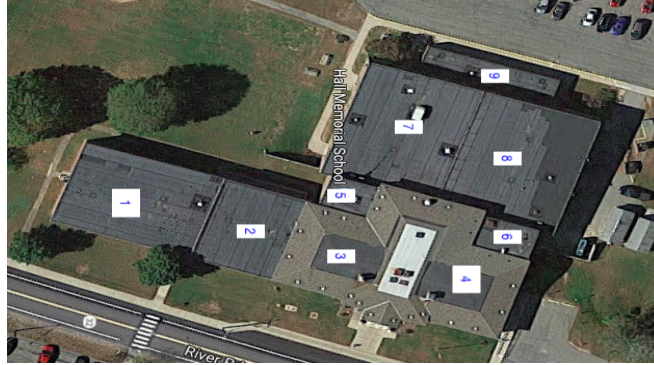
**12. HMS - Roof (All Sections)**

All sections of the Hall School roof are in need of replacement. Numerous leaks occur throughout the building including hallways, classrooms, and offices.

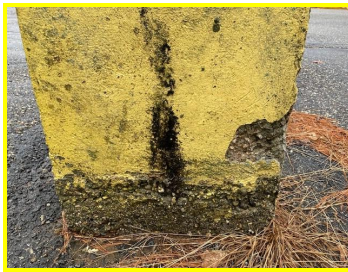
**14. HMS - Parking Lot Light Pole Concrete Replacement (submitted December 2020)**

The base of one of the concrete posts appears to be degrading and may need replacement in the future. This would include the installation of a new concrete base and LED light.
