**2023-2024**  
**Willington Public Schools: Board of Education**  
**Capital Improvement Project Preparation**

**Center School Priorities**

### **Hall School Priorities:**

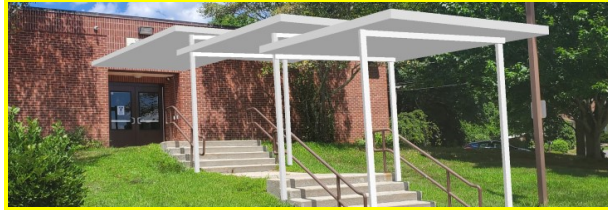
The entrances at the elementary school should have canopies extending to the parking lots. One entrance is used for bus arrival and dismissal and the second entrance is used for student pickup/dropoff. Canopies will dramatically improve the look of the building, and also provide shelter for people entering and exiting the building. They will also provide cover over the stairs protecting them from snow/ice in the winter.

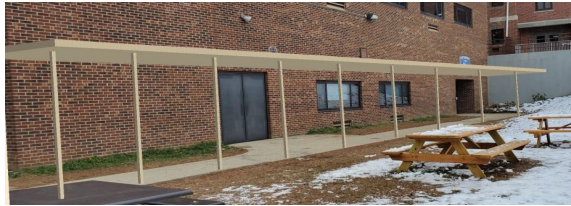
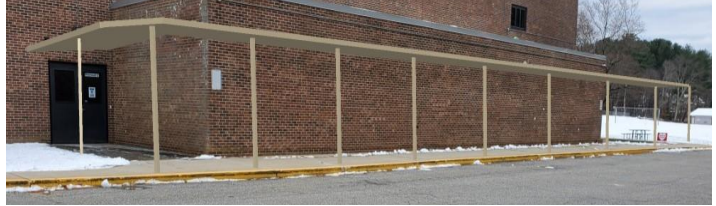
The gym entrance should have a canopy extending to the parking lot and along the back sidewalk. This entrance is used for student arrival and dismissal and a canopy will provide shelter when entering and exiting the building. A canopy will also provide cover from snow/ice in the winter.
